**Flood Control Project Maintenance
Levee Inspections**

Fall 2012 Levee Maintenance Deficiency Summary Report

Sutter Maintenance Yard Maintenance Area 0003

Waterway					Bank	Unit Miles	Inspection Start/End	Inspector	
Unit No. 01 Feather River					Right	5.19	11/27/2012 11/27/2012	Clay Thomas

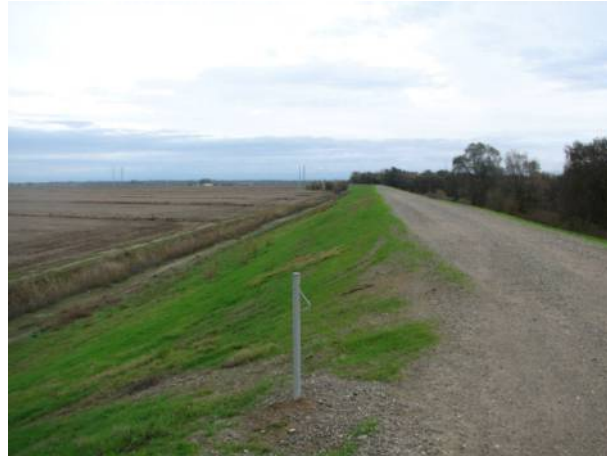
Levee Mile Report Line	4
Start Levee Mile	0.08
End Levee Mile	5.17
Location	Land Side
Category	Earthen Levee
Item	Vegetation

Levee mile 0.05, the landside slope.

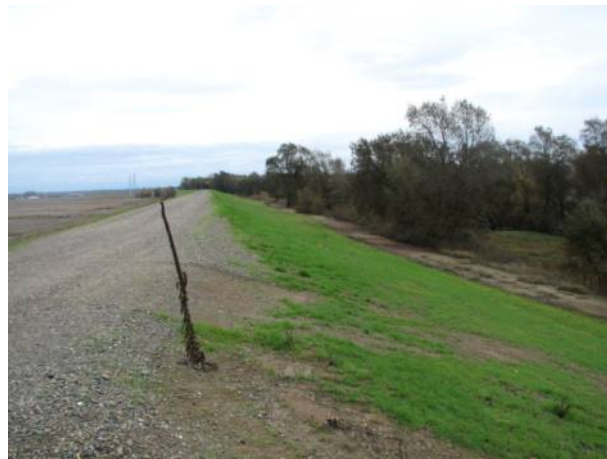
Levee Mile Report Line	5
Start Levee Mile	0.08
End Levee Mile	5.17
Location	Water Side
Category	Earthen Levee
Item	Vegetation

Levee mile 0.05, the waterside slope.

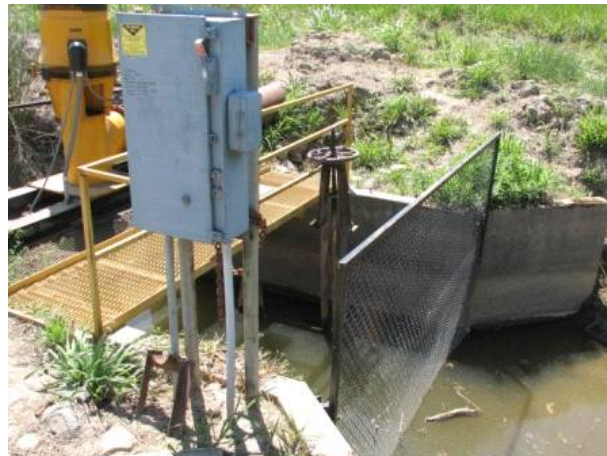
Levee Mile Report Line	6
Start Levee Mile	0.80
End Levee Mile	0.80
Location	Land Side
Category	Interior Drainage & Piping Systems
Item	Sluice / Slide Gates

Levee mile 0.80, this photo is looking at the landside toe, one of these pipes leaked during the high water event of 2010/2011. A flap gate prevents flow from the waterward side to the landward side of the levee.

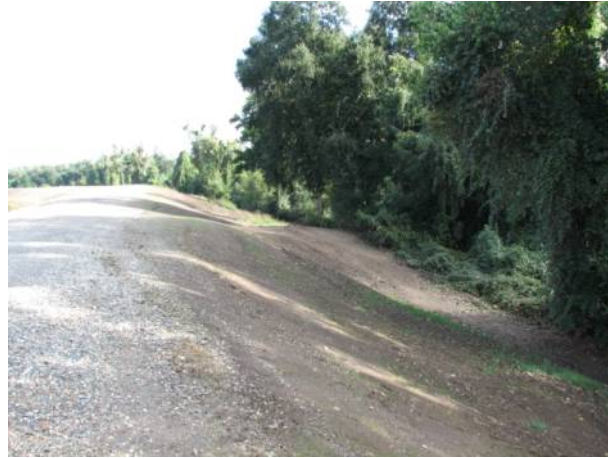
Levee Mile Report Line	8
Start Levee Mile	2.29
End Levee Mile	2.42
Location	Water Side
Category	Earthen Levee
Item	Slope Stability

This photo is the waterside slope looking downstream at levee mile 2.29.

DWR ID: DWR_MA0003_01_s_2012_5										
7	1.72	1.85	Earthen Levee	Crown Surface / Depressions / Rutting	CR	C Ma	C3 : Add appropriate gravel or road base. Grade and compact.	38.906503 ° -121.591216 °	38.907690 ° -121.589415 °	118
DWR ID: DWR_MA0003_01_s_2012_118										
8	2.29	2.42	Earthen Levee	Slope Stability	WSA/W	Ob	S1 : Repair slope instability. Inspector Comments: Material movement on the waterside slope. The LMA should investigate the matter further.	38.912960 ° -121.585220 °	38.914582 ° -121.584106 °	119 Y
DWR ID: DWR_MA0003_01_s_2012_119

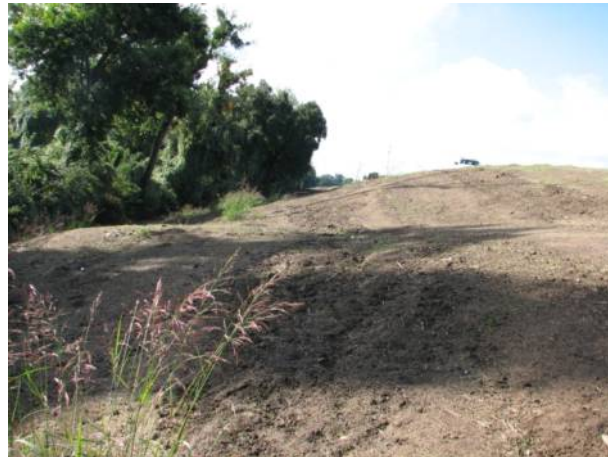
Levee Mile Report Line	8
Start Levee Mile	2.29
End Levee Mile	2.42
Location	Water Side
Category	Earthen Levee
Item	Slope Stability

This photo is the waterside slope looking upstream.
